CONTINENTAL AIRCRAFT ENGINE COMPANY
Detroit, Michigan

May 25, 1934

Report
of
50-Hour Endurance Test
of
Continental Hyper Engine No. 2A

Contract W535 AC 6322

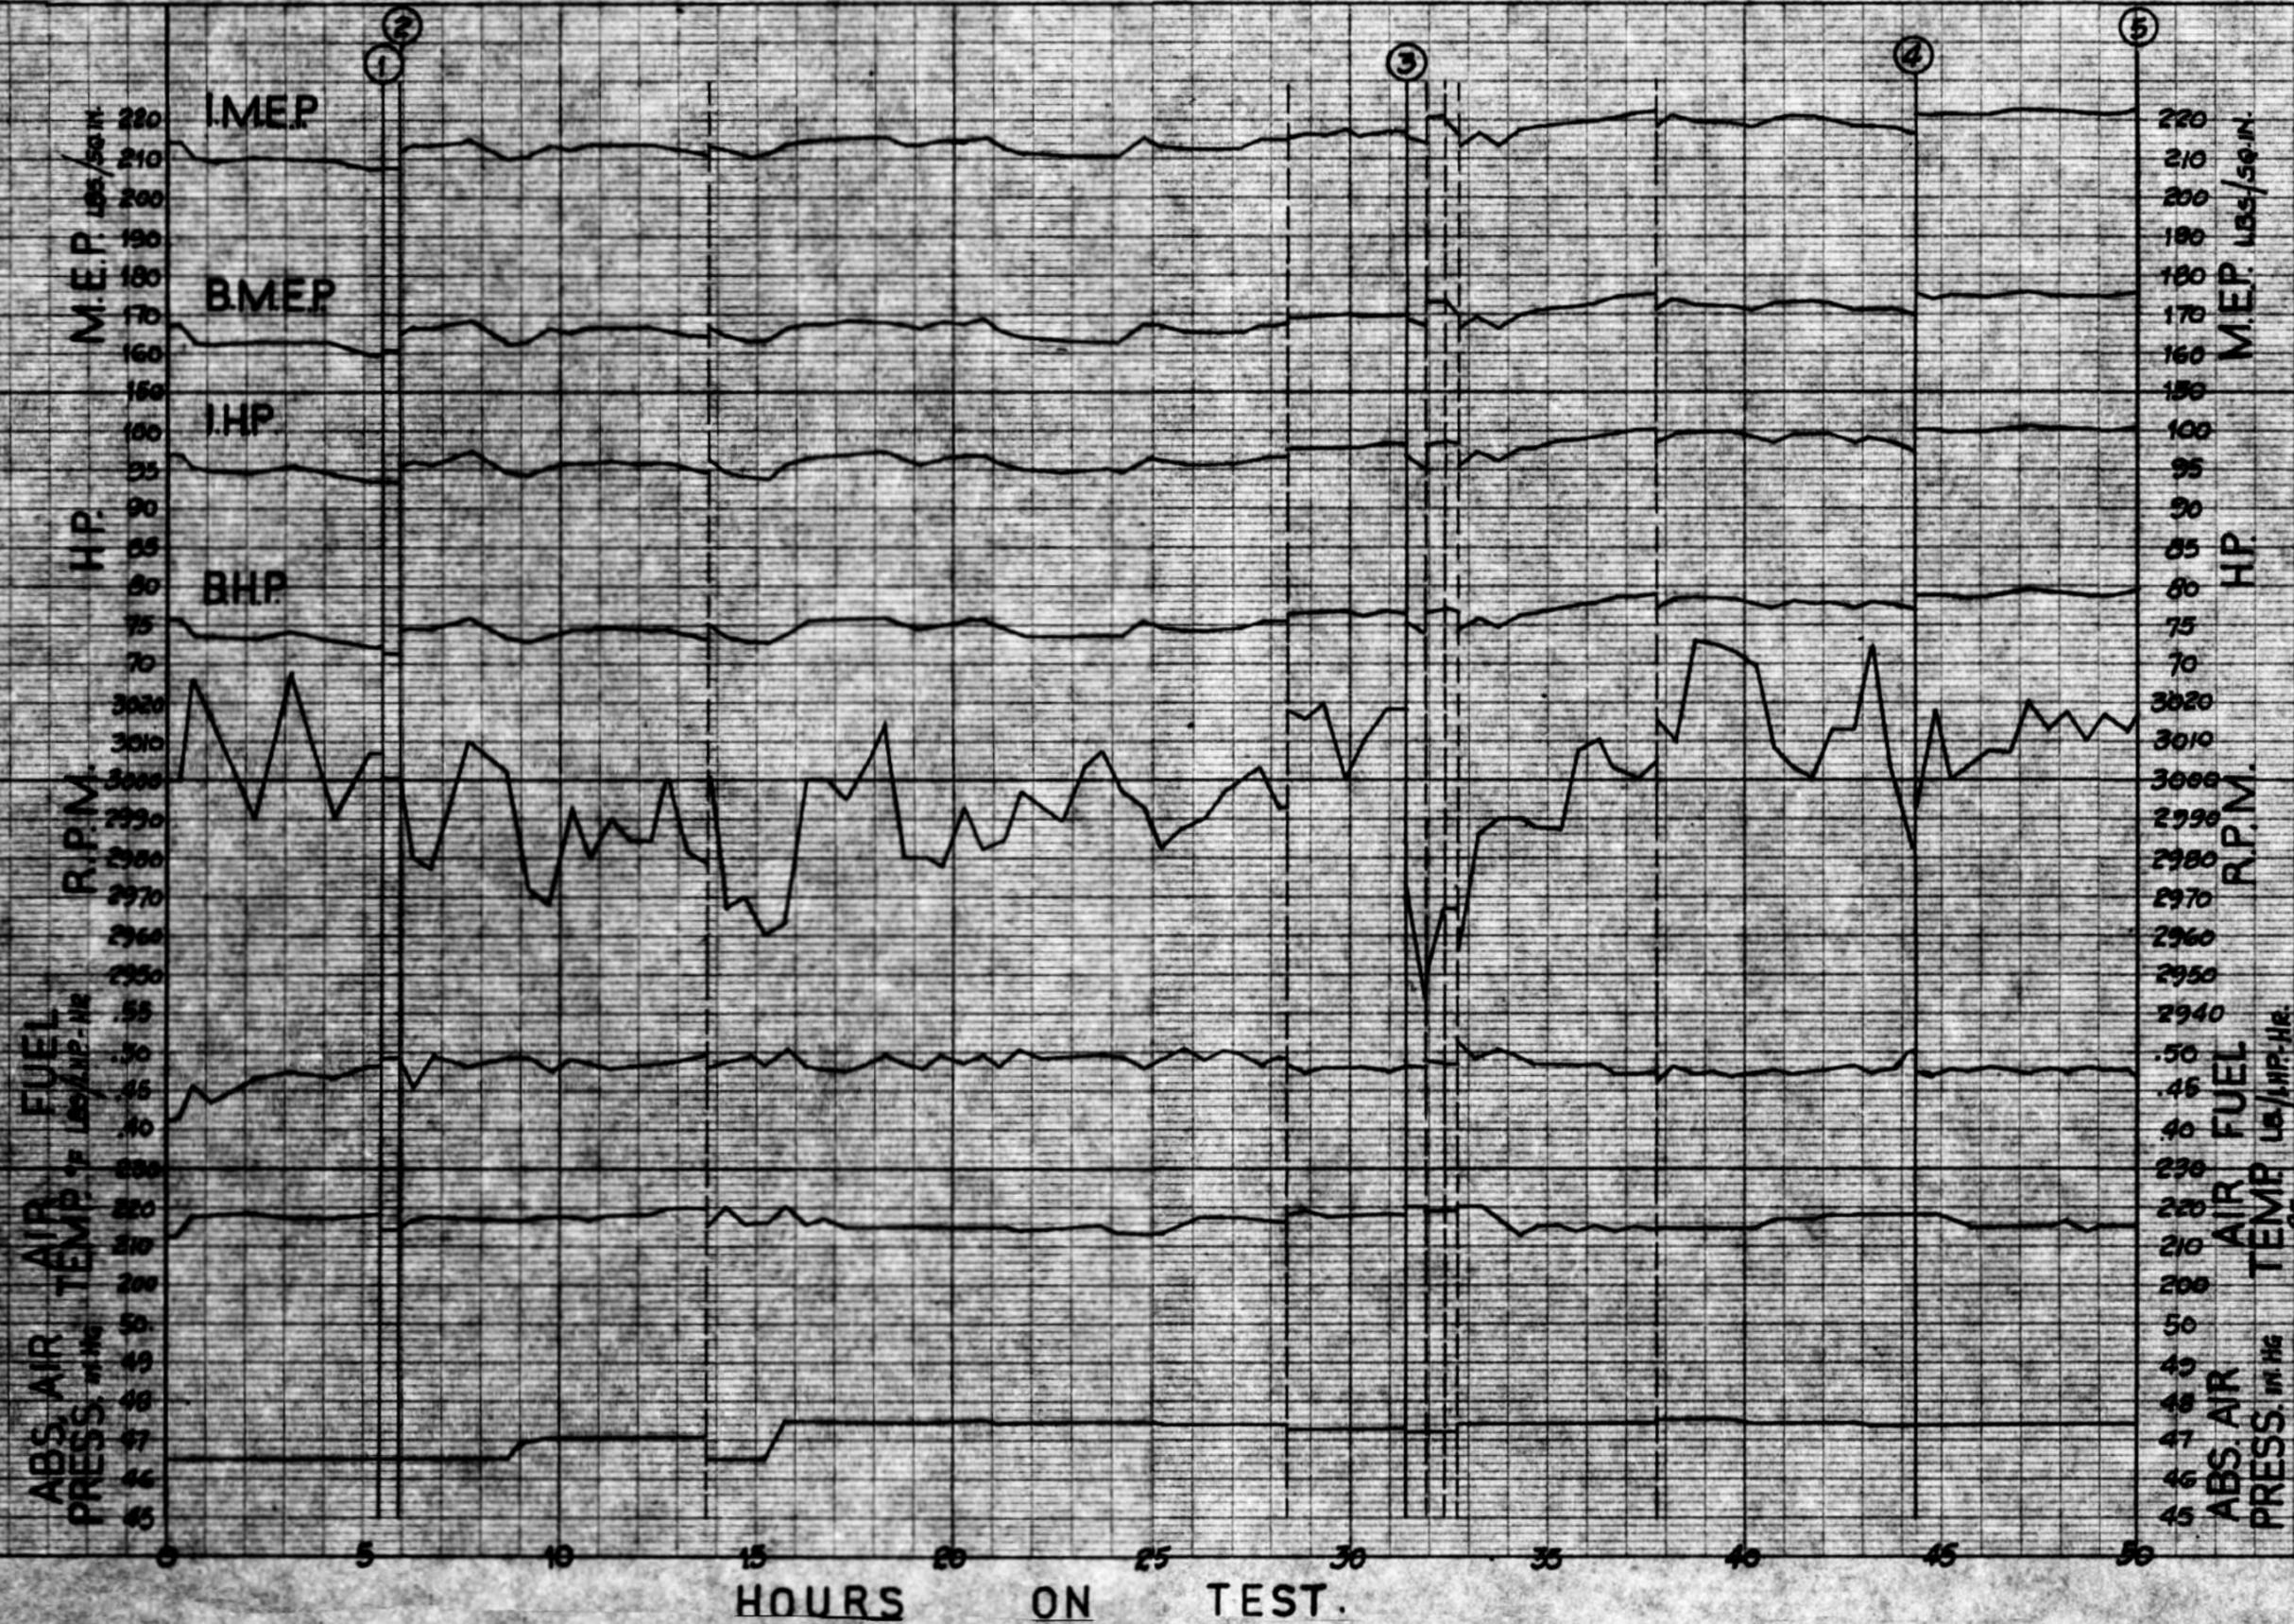
1. 5 hours, 25 min. Ground in exhaust valve. It is thought that the valve seat was not down solidly against the head as this trouble was not encountered again.

2. 5 hours, 55 min. Changed H. T. 300 spark plugs after 6 hours on these plugs. During the first 6 hours an attempt was made to hold the brake specific fuel at .55 lbs. per B.H.P. hr. This resulted in heavy detonation and finally preignition.

3. 31 hours, 25 min. Changed H.T. 300 spark plugs after 25 1/2 hours on these plugs. Lead deposit or deterioration of the insulation caused missing.

4. 44 hours, 20 min. Changed H.T. 300 spark plugs after 15 hours on these plugs. The plugs of stop 3 were used with Stanavo aviation ethyl gasoline No. 87 which ordinarily has 2 c.c. of tetra-ethyl lead per gallon while the plugs of this stop were run with contract gasoline (Y3557-G) which had "not less than 4 c.c. of tetra-ethyl lead per gallon". The higher lead content of the later fuel undoubtedly caused the reduction in plug life.

- STOPS
- ① REMOVED CYLINDER, EXHAUST VALVE SEAT WARPED - REGROUND.
 - ② CHANGED PLUGS - PUT IN NEW HT 300 PLUGS.
 - ③ CHANGED PLUGS - PUT IN NEW HT.300 STOP STANAVO AVIATION ETHYL NO 87 GAS. START CONTRACT GAS (SPEC. Y355TG)
 - ④ CHANGED PLUGS. PUT IN NEW HT 300.
 - ⑤ END OF TEST. TEARDOWN, INSPECTION.
- DOTTED LINES INDICATE STOPS MADE FOR OTHER THAN ENGINE CAUSES.

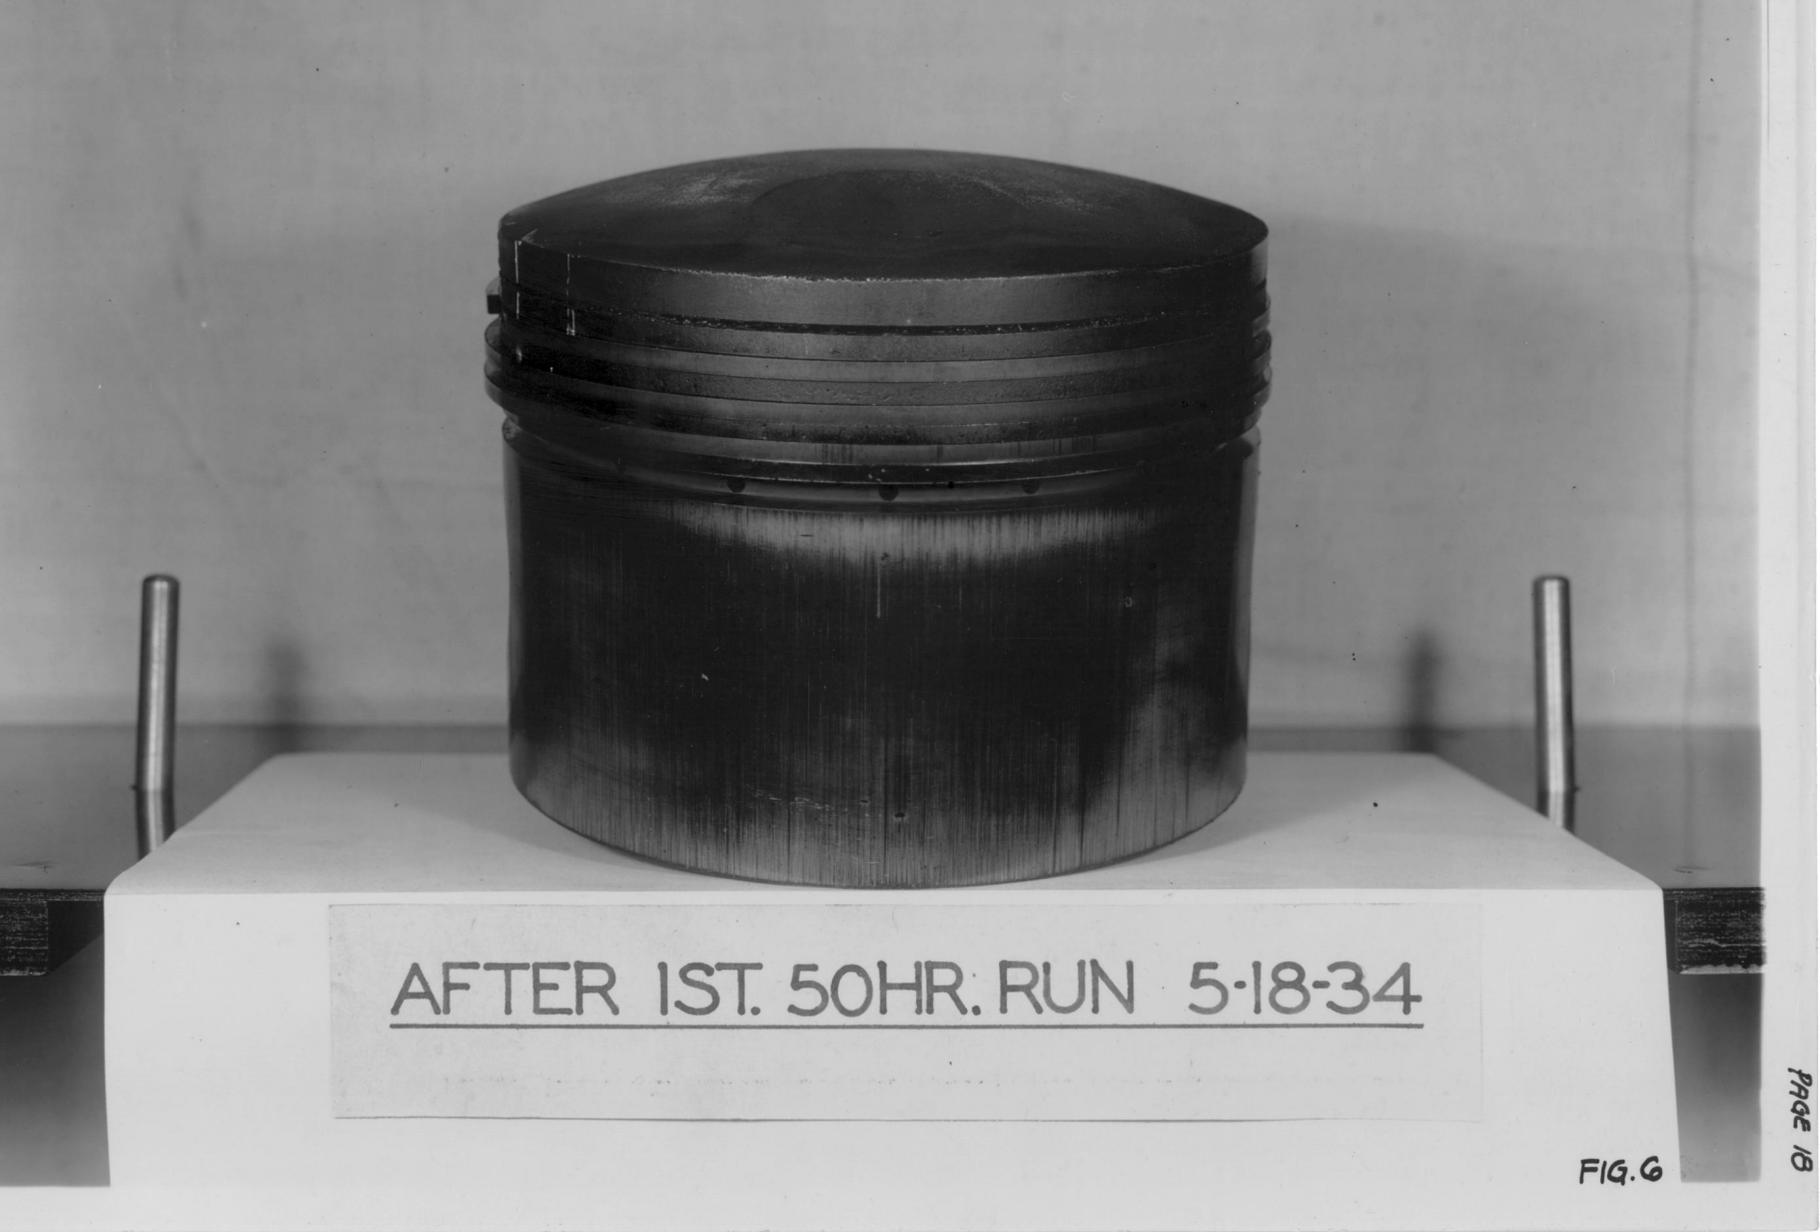
FIG. 6

Figure 1 shows the piston and ring clearances, and Fig. 6 shows the piston thrust side after the endurance run. The heat dam above the top compression ring was nearly filled with carbon, however, this need not impair its effectiveness as a heat dam.

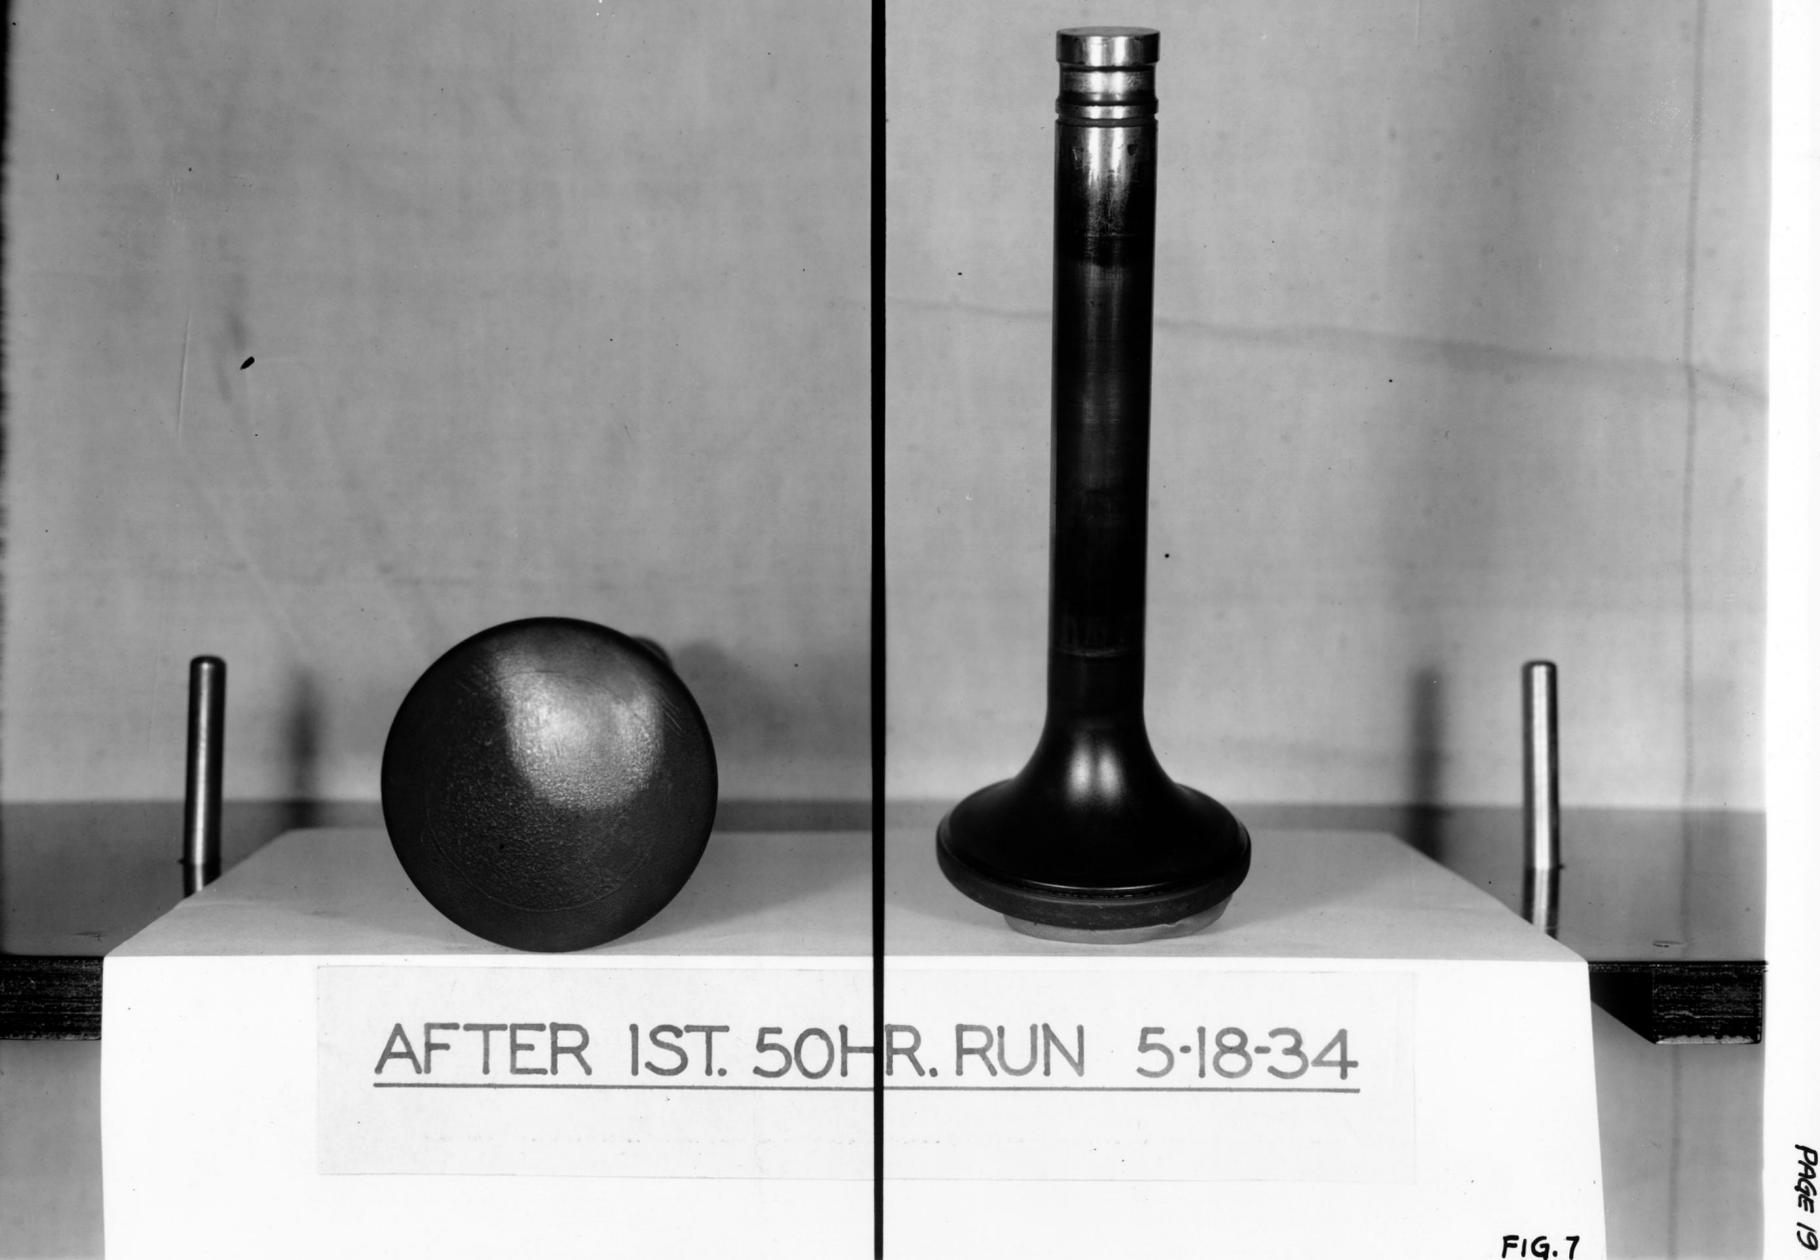
FIG. 7

Visual inspection after the test showed but one fault, the broken oil ring shown in Fig. 8. This failure is thought to have resulted from gas leakage by the compression rings putting pressures on the upper side of the oil ring and breaking it over the slots. The carbon formation on the head of the exhaust valve shows plainly where the stellite joins the steel. This is shown in Fig. 7. No unusual carbon deposits formed anywhere, nor were any parts scratched or unduly worn.

The exhaust valve allowed a slight seepage of gasoline after the test. However, the seat looked good and is shown in Fig. 7. The carbon was wire brushed off in one spot to show the surface.
