SPACE SHUTTLE MAIN ENGINE THE FIRST TEN YEARS

Part 5 – High Pressure Oxidizer Turbopump Explosions

High Pressure Oxidizer Turbopump Explosions

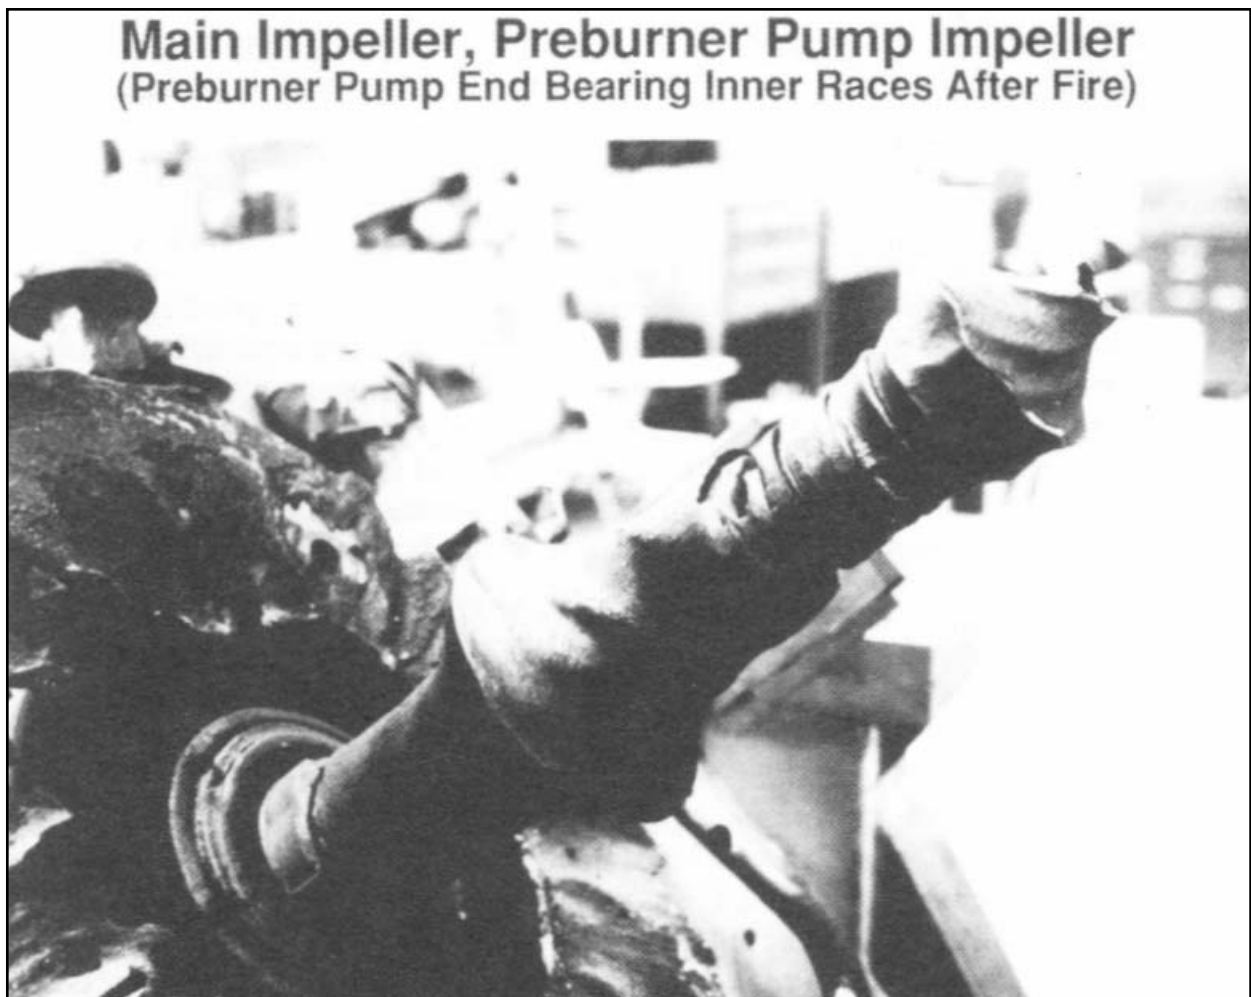
Test 901-136 on Engine 0004 was scheduled for 320 seconds duration on September 8, 1977. The test was prematurely terminated at 300.22 seconds due to loss of engine electrical control, which was caused by a major fire originating in the HPOTP [26]. Through a detailed analysis of the test data, the investigating team was able to trace a series of events leading to the final conflagration that began almost three minutes earlier.

The engine was started to 90 percent power level and then throttled up to RPL. At 133 seconds, the power level was reduced back to 90 percent. Coincident with the power level change, a significant change was observed in the HPOTP vibration characteristics. All accelerometers indicated a slight increase in activity and the three accelerometers on the turbine end began to show a gradual rise in vibration amplitude. This was interpreted as a degradation of the turbine end bearings. At 185 seconds, the turbine end accelerometers had stopped increasing and began decreasing. At the same time, the pump end accelerometers began to increase in amplitude, indicating that radial loads were being transferred from the turbine end bearings to the pump end bearings. At 193 seconds, an increase in the LOX temperature at the main pump discharge indicated internal heat generation. At 200 seconds, the facility-measured LOX flow rate began to deviate from the engine LOX flow rate. This was conjectured to be caused by wearing of the boost pump impeller rear shroud labyrinth seal, resulting in increased recirculation flow from the boost pump back to the main pump inlet. Many measurements showed an increasing turbine power requirement for the rest of the test, indicating a continuing increase in internal friction. At 275 seconds, measurements in the HPOTP drain lines began to show evidence of increased clearances and heat generation in the seals. The condition of the HPOTP continued to degrade until 300 seconds when the rotor attempted to seize up, leading to a failure of the low pressure LOX duct. This caused the HPOTP to cavitate and overspeed, and an internal fire burned through to outside the pump and destroyed control system wiring which led to a cutoff command.

The failure scenario was fairly conclusive but incomplete. Neither the data nor the remaining hard-

ware contained clues as to what caused the gradual failure of the turbine end bearings. (see Figure 16). An in depth analysis was conducted covering 31 potential failure modes [26]. Each failure mode was evaluated using a fault-tree diagram to describe how it could have caused or contributed to a fire in the HPOTP Supporting and refuting evidence was obtained from test data, prior experience, hardware inspections, previous pump conditions, analytical models, and other sources. The team concluded that the most probable initial failure cause was wearing of a turbine end bearing due to uneven load sharing and inadequate cooling. It was also concluded, however, that it was almost as likely that the first failure was in a pump end bearing. Because of the lack of conclusive evidence, all failure modes that were judged to have sufficient supporting evidence and, more importantly, those with insufficient refutative evidence, were placed in the final potential cause list. Seven basic failure modes were identified, with an average of three root causes each. For each of these, short-term and long-term action was taken to reduce or eliminate the potential for a similar event in the future.

Figure 16. HPOTP Rotor After Test 901-136 (Photo No. 89c-4-1029)

On September 26, 1977, just 18 days after the incident, testing was resumed with Engine 0002 using an HPOTP with enhanced internal instrumentation. Changes were incorporated that would improve bearing coolant, equalize bearing load sharing and reduce bearing loads. Improved dynamic lancing of the rotor resulted in an immediate reduction in vibration levels and synchronous loads. Although additional improvements were to be made later in the program [25], these changes effectively resolved the failure mode of Test 901-136.
