# SPACE SHUTTLE MAIN ENGINE THE FIRST TEN YEARS

## Part 6 – High Pressure Fuel Turbopump Turbine Blade Failures

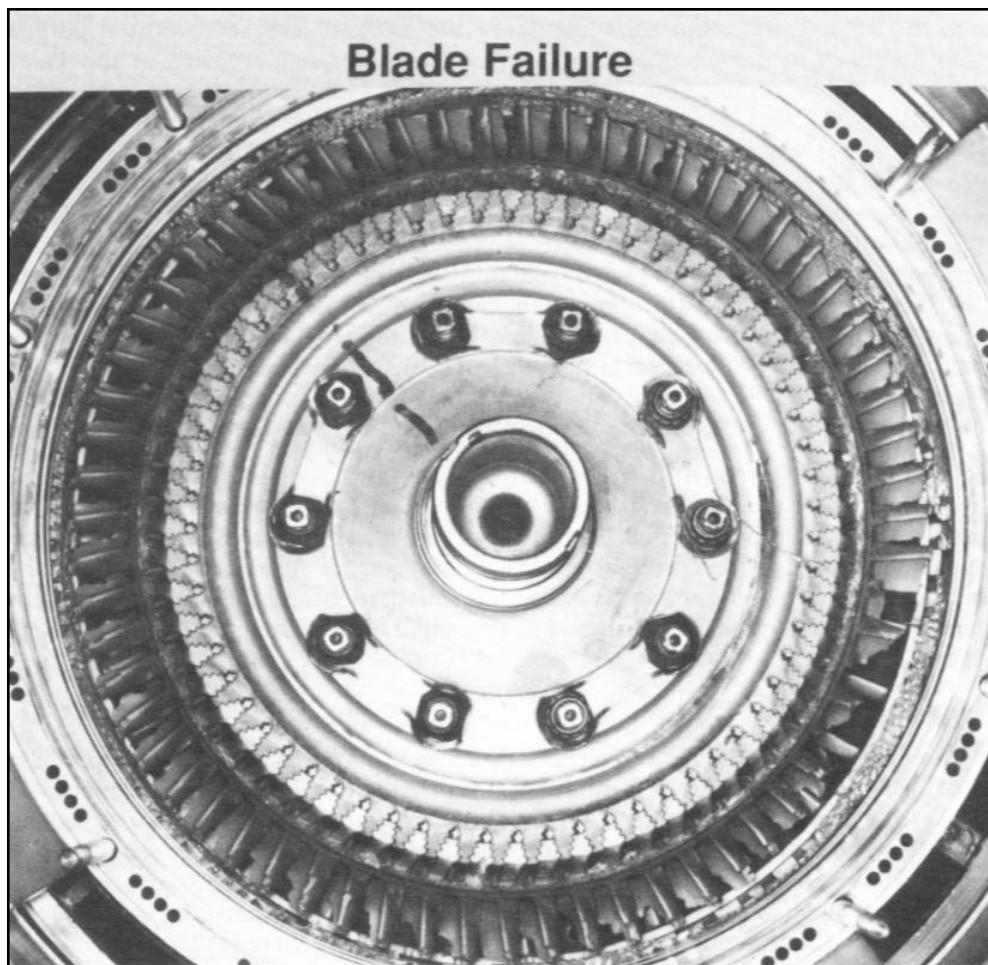
violently shook the entire engine. The test was not shut down by the HPFTP vibration monitor because it had a built-in time delay of 0.240 seconds, and the HPOTP redline time delay was only 0.100 seconds. A post-test inspection revealed that a first-stage turbine blade had broken off and inflicted significant damage to both turbine stages. Figure 17 shows the damage to the first-stage wheel. The engine was shut down safely

Figure 17. HPFTP First Stage Turbine - Test 902-095 (Photo No. SC89c-4-1032

With the hardware evidence, data analysis and other blade samples, it was shown that the failures were initiated by a high cycle fatigue crack in the air-foil of a first-stage turbine blade, close to the root. Consultation with government, industry and academic experts led to a comprehensive laboratory test program at Rocketdyne, General Electric, TRW and AiResearch [25]. Tests were conducted to evaluate blade vibration; static loads; high-temperature, high-cycle fatigue; blade platform loading and damper performance. At the same time, material property tests were run to determine thermal shock effects, heat effect on microstructure, and characteristics of fatigue and stress rupture failures.

and that all damper configurations tested were effective in reducing the effect of engine-induced vibration modes that could contribute to blade failure. An optimized, lightweight precision-tolerance damper design was selected after a review of the Whirligig test data (Figure 19). The new damper design was incorporated along with changes to preclude blade lock-up either in the wheel or blade-to-blade. A looseness verification

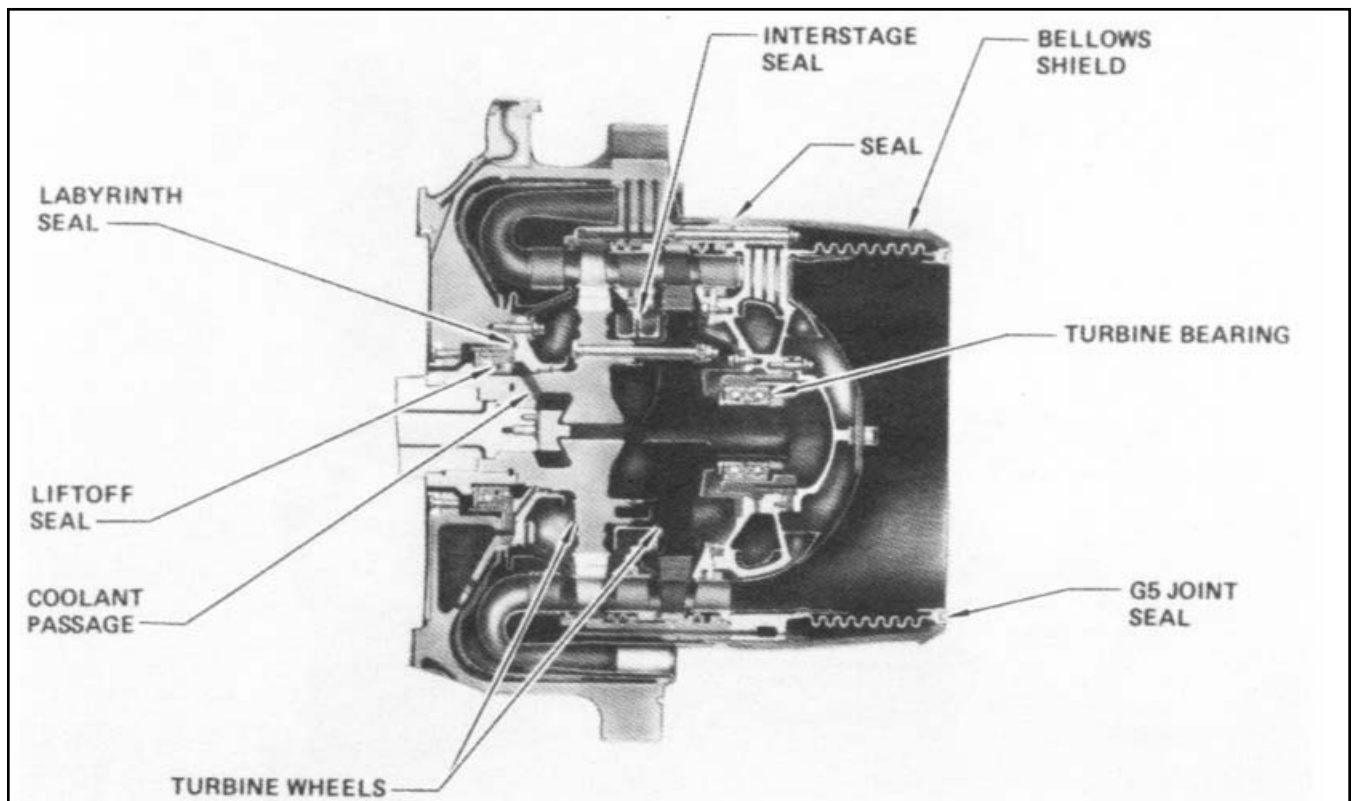
**Figure 18. HPFTP Turbine Section (Photo No. SC433-20)**

The HPFTP turbine (Figure 18) is a two stage reaction turbine powered by hot hydrogen-rich steam produced by the FPB. The turbine drive gas is directed by 41 first-stage nozzle vanes into 63 first-stage turbine blades. The first-stage exhaust is gathered by 39 second-stage nozzle vanes and redirected through 59 second-stage turbine blades. (The number of elements were purposely made different to minimize the possibility of frequency reinforcement among the various parts.) The turbine exhaust gas is then guided by sheet metal structure through a 180 degree turn to be consumed in the MCC. The turbine blades are about one inch long by half an inch wide with a ribbed extension called a "fir tree," which it resembles (Figure 17). The blades are installed by inserting the fir trees into matching slots in the gold plated turbine disc, and they are held in place by pressure loading and centrifugal force. The blades are structurally independent of each other except for small spring-like devices that fit between the blade shanks in slots provided at the blade platforms. These are called dampers and are used to dampen blade vibration. Because the power generated by the HPFTP amounts to about 600 horsepower per blade, the blades are under tremendous stress. The power bending stress and the centrifugal stress are each approximately 50,000 psi for every blade. The

blades are uncooled and -operate at a temperature of about 2,000 R. The turbine blade material for this, very severe environment was chosen based on tests conducted in 1971. The blades are directionally solidified castings of a nickel-based super alloy known as MAR-M-246 (developed by Martin Metals).
