# SPACE SHUTTLE MAIN ENGINE THE FIRST TEN YEARS

## Part 7 – Main Oxidizer Valve Fire, Main Fuel Valve Fracture, Nozzle Feed Line Failures

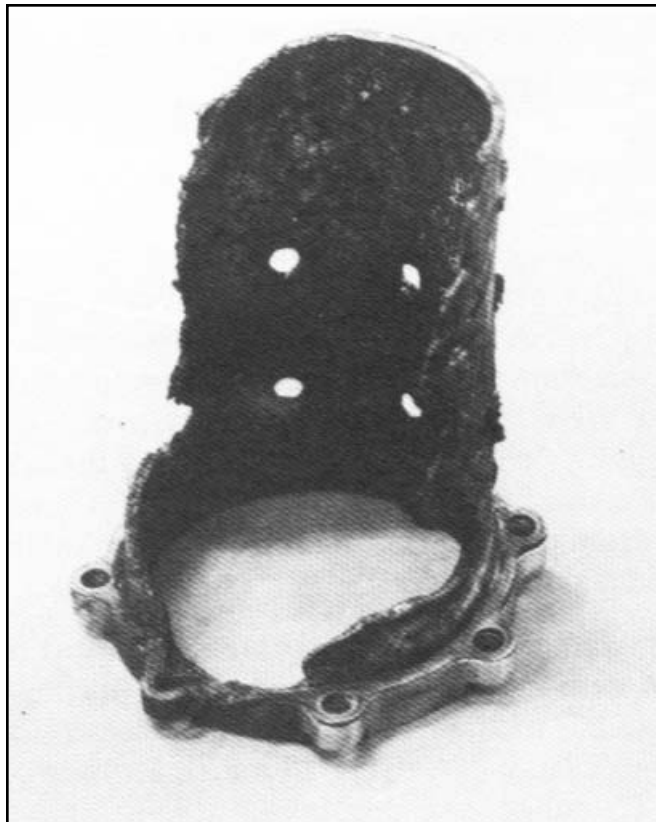
Disassembly of the MOV from the incident test revealed that the bellows had been burned away and the inlet sleeve was 50 percent consumed. (see Figure 21) A dynamic analysis using two-dimensional and three-dimensional models, showed that the inlet sleeve had a fundamental natural frequency of about 1,900 Hz, which corresponded to a high energy vibration generated by the HPOTP (four times pump speed). This was augmented by data obtained from a simulated LOX feed system test facility set up by NASA at MSFC to study flow under controlled laboratory test conditions [31]. It was shown that the energy generat-

**Figure 21. MOV Inlet Sleeve After Test 9001-225. (photo No. 307-971)**

ed by the HPOTP was enough to excite the sleeve frequency and loosen the preload on the bolts attaching the sleeve to the valve inlet flange. The team concluded that excessive vibration in this loosened condition caused the very thin steel shims to ignite, causing the fire. Disassembly of valves from prior engines confirmed this potential by showing evidence of fretting and broken shims.

Several design changes were incorporated, the most important being replacement of the shims with a single 'machined spacer having a minimum 0.040 inch thickness. To change the natural frequency of the sleeve assembly, the material was changed from 21-6-9 CRES to INCO 718 and the wall thickness was increased by about 75 percent. To minimize the potential for fretting, the sleeve diameter was increased to be an interference fit; the spacer material was changed from 302 CRES to INCO 718; and the attaching screws were countersunk with cup washers to provide positive locking.

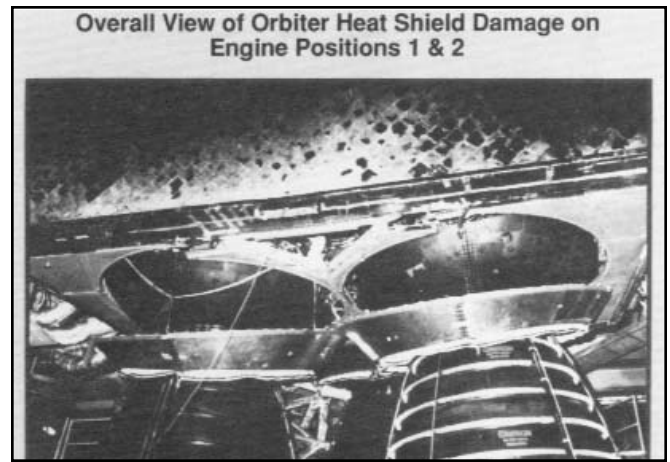
In April 1978, at the NASA/NSTL test site, a test series was initiated on a simulated Space Shuttle orbiter aft section, including a cluster of three main engines. This combination of hardware was known as the Main Propulsion Test Article (MPTA) and was used by NASA to conduct full-up system tests of the entire orbiter propulsion system. On July 2, 1979, MPTA Test SF06-01 was scheduled for a 520 second flight mission simulation test. At about 18 seconds, the MFV housing on Engine 2002 developed a major fracture which allowed hydrogen to leak into the enclosed aft compartment. The loss of fuel in the engine caused both turbine temperatures to increase; and the HPFTP turbine temperature exceeded its redline value, which caused engine shutdown to be commanded for all three engines. During this time the pressure in the aft compartment increased as a result of vaporizing the hydrogen. Almost at the same time as the shutdown command, the aft compartment pressure reached 3.2 psi [32], which exceeded the structural capability of the aft compartment heat shield supports. Figure 22 shows how the heat shields around each engine were blown off. Major structural damage was sustained in the aft section of the MPTA. An external fire ensued which caused minor damage, mostly to instrumentation wiring; but there was no fire, damage inside the aft compartment.

**Figure 22. MPTA Heat Shield Failure (Photo No. SC89C-4-1010)**

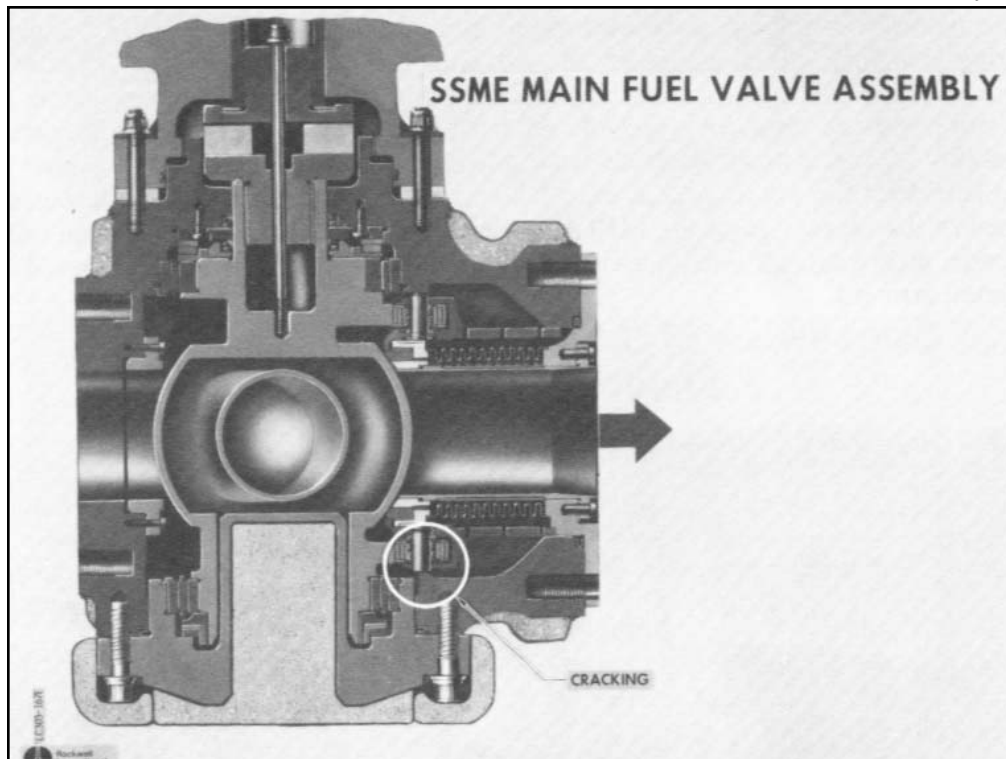
**Figure 23 Main Fuel Valve (Photo No. LC303-167E)**

to overload. The SEM analysis clearly indicated the fracture origin to be at the location of a cutout in the housing designed for the ball seal retraction cam follower (see Figure 23). There was no evidence of material or forging defects, and the microstructure was normal for this titanium alloy. The material composition was verified to be correct by chemical analysis. Proper mechanical properties were verified by testing forging samples which were made as extensions on the housing in the original forging and then using sample bars machined from the fractured housing. Although SEM analysis identified areas in the originating fracture surface that indicated propagation by fatigue, other features identified by the SEM were indistinguishable from stress corrosion, hydrogen embrittlement, or low amplitude fatigue.

Fifteen hypothetical failure modes were investigated in detail. Extensive testing and analysis at Rocketdyne, MSFC and the various research centers managed to disprove 11 of them; however, the available evidence was insufficient to narrow the failure cause down further than the remaining four hypothetical failure modes. Therefore, positive action was taken to eliminate all of them for future valves. Aside from process changes, the cam follow-

er cutout area was reworked on all existing housings to provide generous radii for up to 30 percent reduction in stress concentration. In addition, for long-term recurrence control, the valve housing was redesigned to reduce the peak strains to 80 percent of yield.
