SPACE SHUTTLE MAIN ENGINE THE FIRST TEN YEARS

Part 8 – Fuel Preburner Burn Through

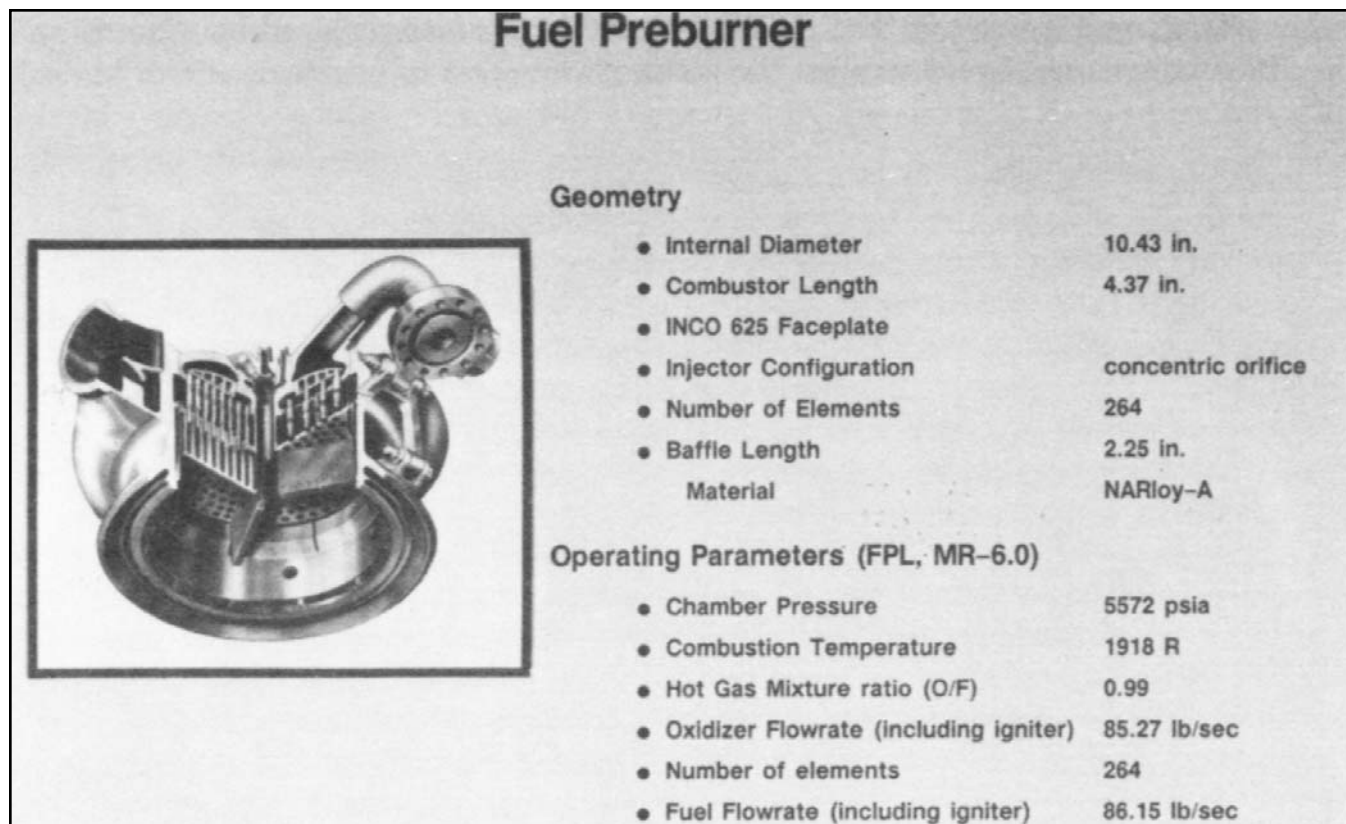
Figure 25 Fuel Preburner (Photo SC89c-4-1020)

The FPB (Figure 25) provides the turbine drive gas for the HPFTP. It consists of two propellant manifolds, a centrally located ASI, an injector and a short combustor section welded together into the major hot gas manifold that also includes the oxidizer preburner, the high pressure turbine exhaust gas flow path and the injector for the main combustor. The FPB injector is a coaxial element injector with each element having low

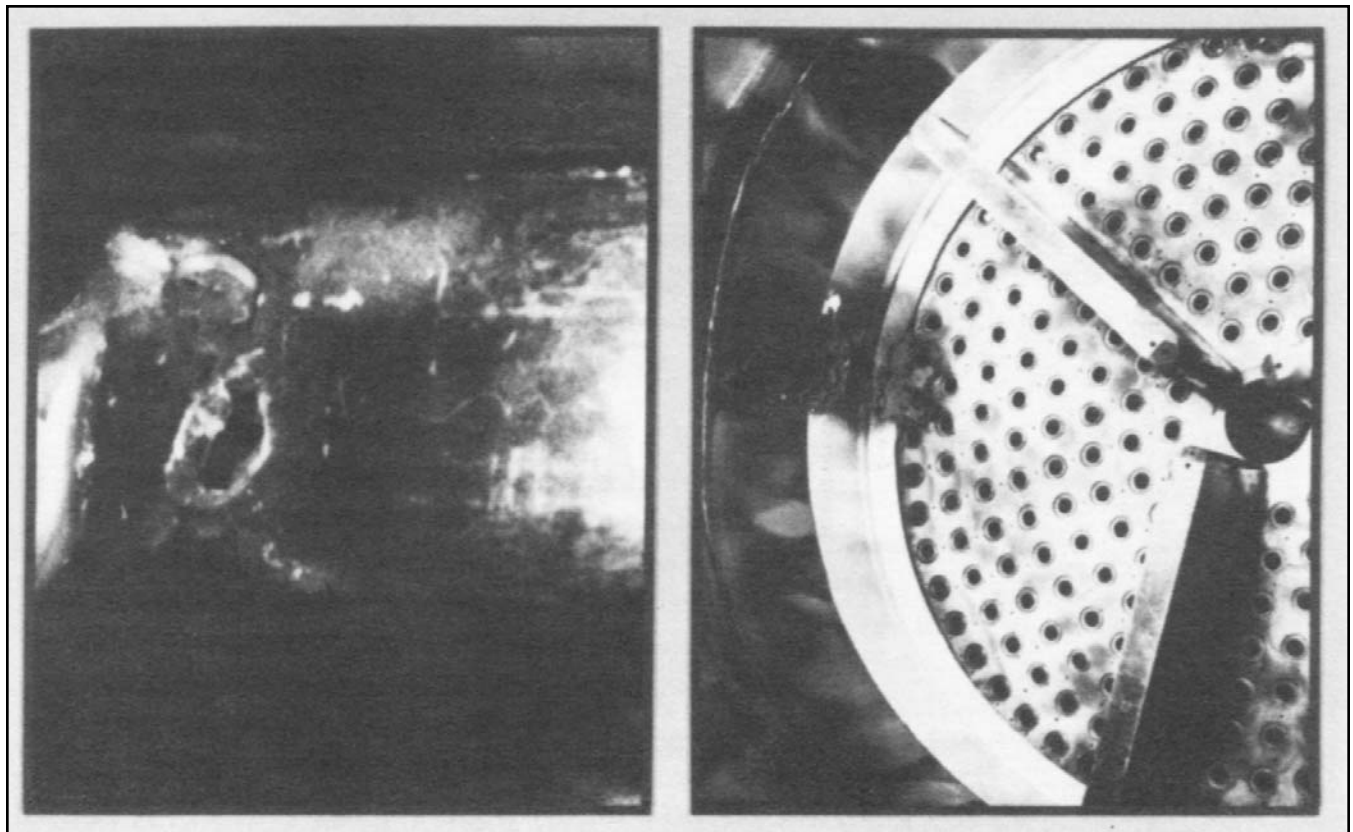
Figure 26 Engine 0006 Fuel Preburner (Photo No. SC89C-4-1013)

The second failure, in 1980, was located six elements away from a baffle (Figure 26) and was determined to be caused by a different mechanism [39]. Inspection of the preburner elements showed no evidence of contamination which could have caused fuel blockage; however, it was discovered that the individual element LOX posts were not concentric with the fuel annuli, causing a fuel restriction on the outboard side of the outer row elements. Further inspection showed that the lack of concentricity was caused by a deformity of the face plate in which it was bowed outward almost a tenth of an inch, half way between the center and the outer row. The investigating team [39] concluded from the inspection of all other preburners that the bowed condition was unique to the failed unit. In addition, a review of historical problem reports disclosed that this FPB had experienced more reported cases of overheating or minor erosion than all other preburners combined. The cause of the deformity was never identified; however, periodic inspections were added for all preburners to verify outer row element concentricity in the future.

Even though the failure was caused by a unique hardware condition, a major effort was undertaken to preclude additional occurrences of this type of problem by making the preburner insensitive to maldistribution of the propellants. A two dimensional, four times scale, water-flow model was constructed and tested to evaluate propellant streamlines in the outer row and along the liner wall. Two flow paths were discovered which could contribute to burning if the localized gases were at a higher mixture ratio. A recirculation field existed along the liner wall for about three inches (twelve inches on the water table) which disrupted the local boundary layer and increased the potential heat transfer. The flow path was found to be caused by the existence of an empty space along the face plate between the element and the liner. The recirculation was eliminated by the incorporation of a new liner which added a divergent section on the inside of the liner to occupy the empty space. To further reduce the potential heat transfer to the liner, the new liner was coated with zirconium oxide. Another flow path was found which would cause hot gas to flow into the coolant circuit between the liner and the FPB body.

With a small axial gap between the liner and the faceplate, the fluid at the faceplate would be forced by an adverse pressure gradient to flow through the gap into the coolant circuit. The new liner included coolant flow control orifices which assure that the coolant flow pressure is always higher than the hot gas pressure. This favorable pressure gradient prevents flow through any gap and also acts as an erosion inhibitor by automatically cooling any small hole in the liner with additional hydrogen.

Tests with purposely misdirected elements were conducted to verify the effectiveness of these design changes in preventing liner erosion. It has also been shown that even if a hole were placed in the liner, hot gas would not flow into the coolant circuit. Even so, a "belt and suspenders" approach was taken with this problem by adding a thermal barrier on the inside of the FPB body which would withstand the previously experienced failure conditions for a long enough time - to complete a flight mission without failing. A ceramic thermal shield made of molybdenum and coated with disilicide was designed to be bonded to the FPB body.
