CONTINENTAL AIRCRAFT ENGINE COMPANY
Detroit, Michigan

May 25, 1934

Report
of
50-Hour Endurance Test
of
Continental Hyper Engine No. 2A

Contract W535 AC 6322

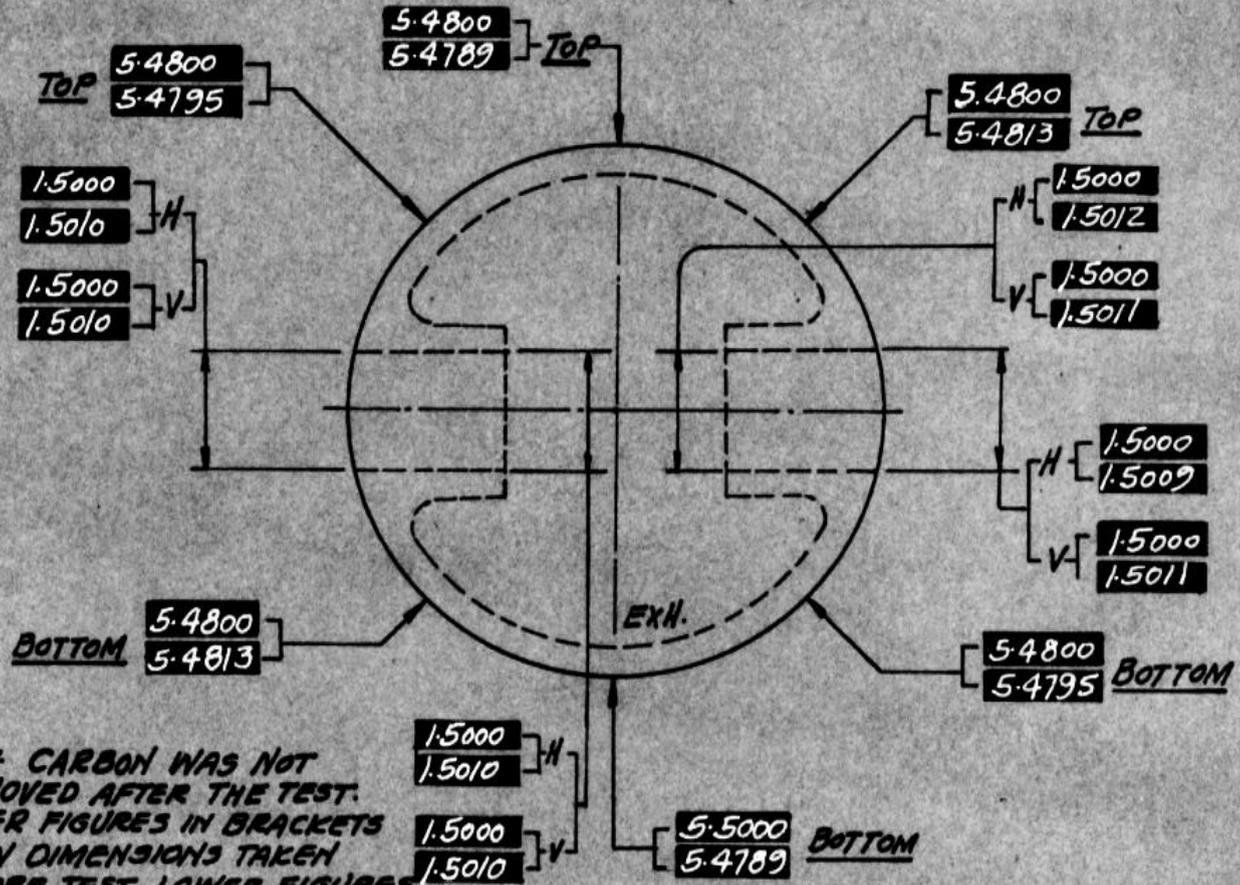
FIG. 3

No part or bearing was worn excessively as shown by the dimensional records, Figs. 2, 3, 4, and 5. The greatest wear shown is for the rocker arm bushing which was .0015 on the vertical diameter.

LAND DIA.	TOP	2	3	4
BEFORE	5.4710	5.4730	5.4680	5.4760
AFTER MAX.	5.4732	5.4808	5.4821	5.4824
AFTER MIN.	5.4711	5.4740	5.4771	5.4775

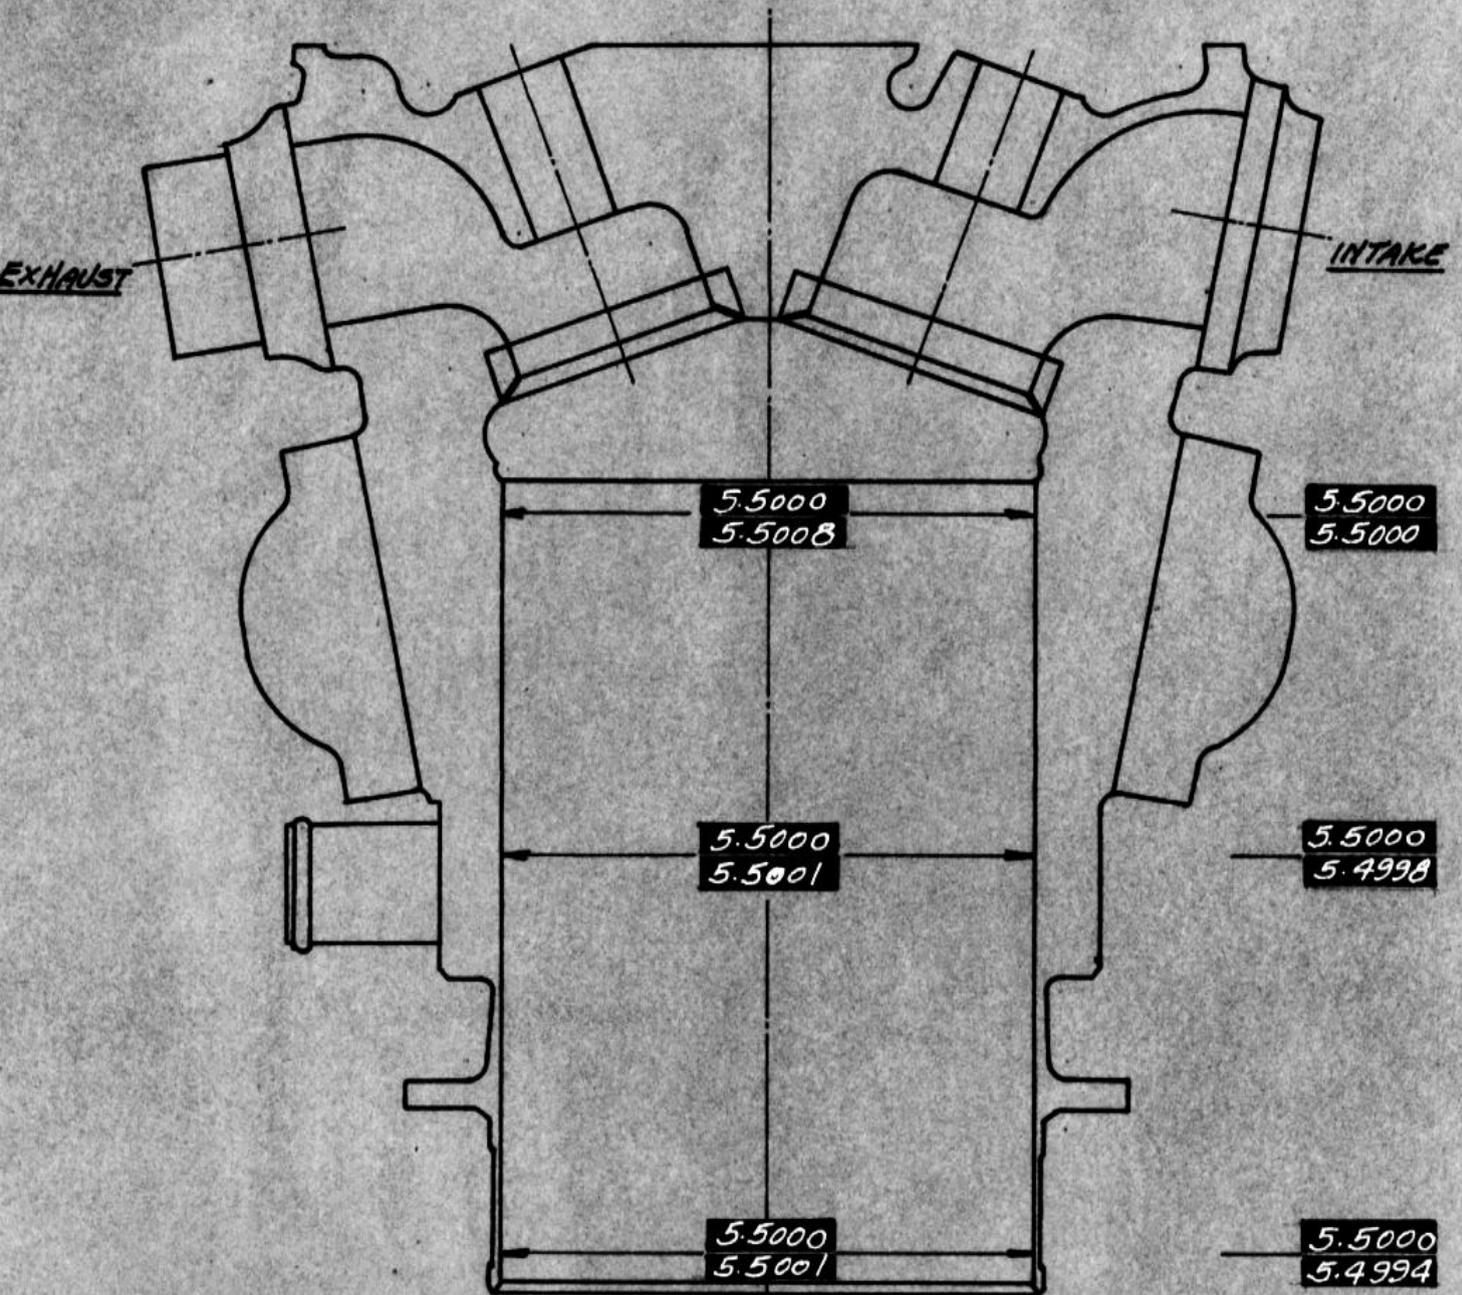
The cylinder bore changed less than .001 in any direction and the average wear was about .0002.

NOTE: INSIDE MICROMETERS USED FOR ALL READINGS. UPPER FIGURES SHOW DIMENSIONS TAKEN BEFORE START, LOWER FIGURES SHOW DIMENSIONS TAKEN AFTER TEST. ENDURANCE TIME = 50 Hours
