# SPACE SHUTTLE MAIN ENGINE THE FIRST TEN YEARS

## Part 7 – Main Oxidizer Valve Fire, Main Fuel Valve Fracture, Nozzle Feed Line Failures

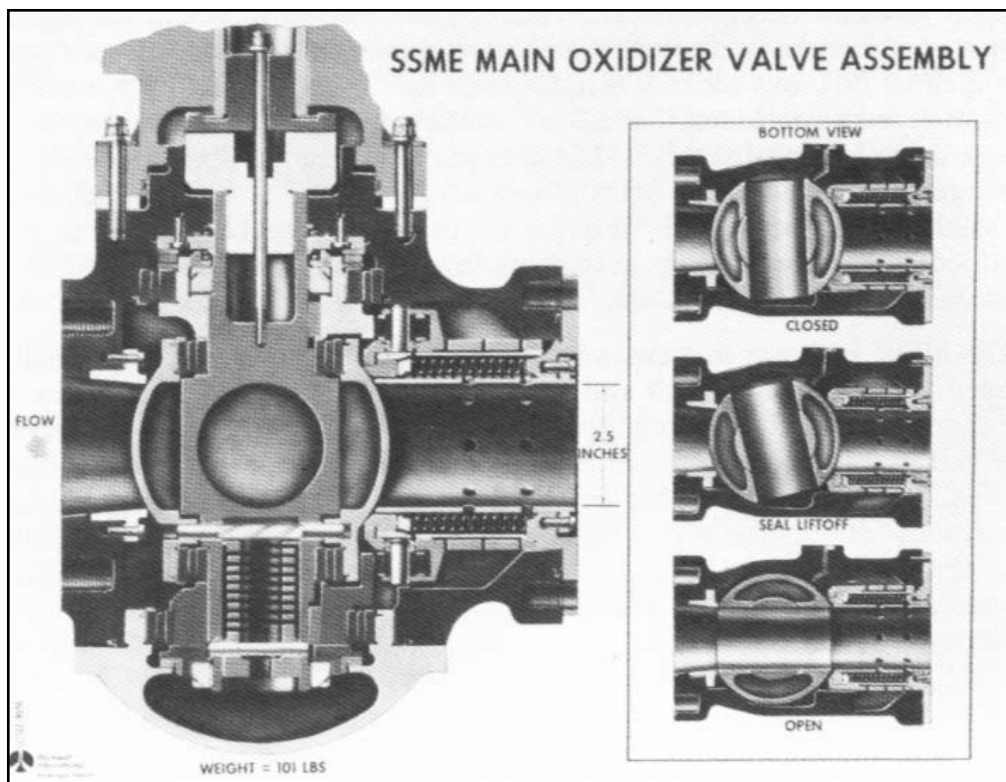
The MOV is shown in a cutaway representation in Figure 20. It is a ball valve fabricated with an integral ball and shaft. The valve is rotated by a hydraulic actuator (not shown) spline-coupled to the shaft at the top of the valve assembly. The hollow ball is approximately 5 inches in diameter with a 2.5 inch tubular flow passage. At the FPL flow rate of 850 pounds per second, the fluid velocity through the valve exceeds 350 feet per second. The ball seal is a machined

Figure 20. Main Oxidizer Valve (Photo No. LC301-865E)

plastic ring which is loaded against the inlet side of the ball by a bellows. The shaft has two integrally machined cams which push against a cam follower mechanism which lifts the seal from the ball during the first six degrees of valve rotation. The LOX flow for the MCC ASI is supplied from a port immediately downstream of the seal and begins to flow as soon as the seal is lifted. To minimize turbulence, a 2.5 inch diameter inlet sleeve is bolted to the valve inlet, isolating the bellows from the flow environment and aligning the flow stream with the ball tubular flow passage in the open position. The sleeve was positioned to a fixed gap between the ball and sleeve by using a stack of 0.002 inch thick stainless steel shims under the bolted inlet flange.

Several design changes were incorporated, the most important being replacement of the shims with a single 'machined spacer having a minimum 0.040 inch thickness. To change the natural frequency of the sleeve assembly, the material was changed from 21-6-9 CRES to INCO 718 and the wall thickness was increased by about 75 percent. To minimize the potential for fretting, the sleeve diameter was increased to be an interference fit; the spacer material was changed from 302 CRES to INCO 718; and the attaching screws were countersunk with cup washers to provide positive locking.

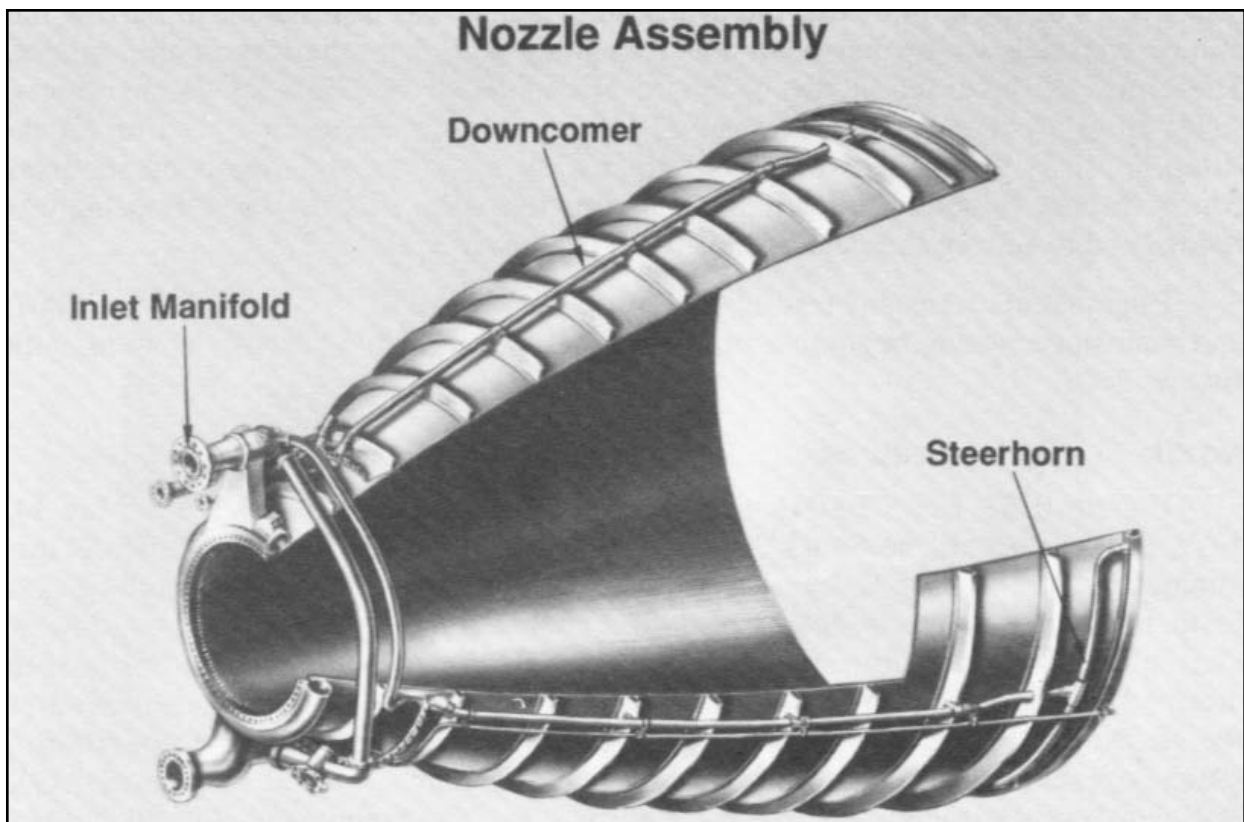
**Figure 24 SSME Flight Nozzle (Photo No. SC89c-4-1012)**

The failure occurred in the number one steerhorn, which is directly beneath the MFV. The entire right-hand section of tubing had broken off from the nozzle, between the welds at the tee fitting and the aft manifold. Most of the tube was recovered as a single piece; however, extensive fragmentation had taken place at both ends, and some of the fragments were not found. Metallurgical analysis of the recovered pieces disclosed that most of the fracture surfaces were indicative of simple ductile failure due to overload. It was concluded that the fracture at the end of the tube started at a low cycle fatigue crack 0.003 inch deep by 0.75 inch long located in the heat affected zone adjacent to the tee weld. Fracture initiation the manifold end was uncertain because not all of the fragments were recovered although no fatigue indications were evident in the fragments that were found. No material deficiencies or fabrication defects were found in any of the recovered pieces.
